44TH TURBOMACHINERY & 31ST PUMP SYMPOSIA
HOUSTON, TEXAS | SEPTEMBER 14 – 17 2015
GEORGE R. BROWN CONVENTION CENTER

Fit For Purpose Unique Machinery Repair Techniques for Late in Life Production Facilities

Case Study 1 – Eroded Compressor Diaphragm

Case Study 2 – Bent High Speed Gear Rotor

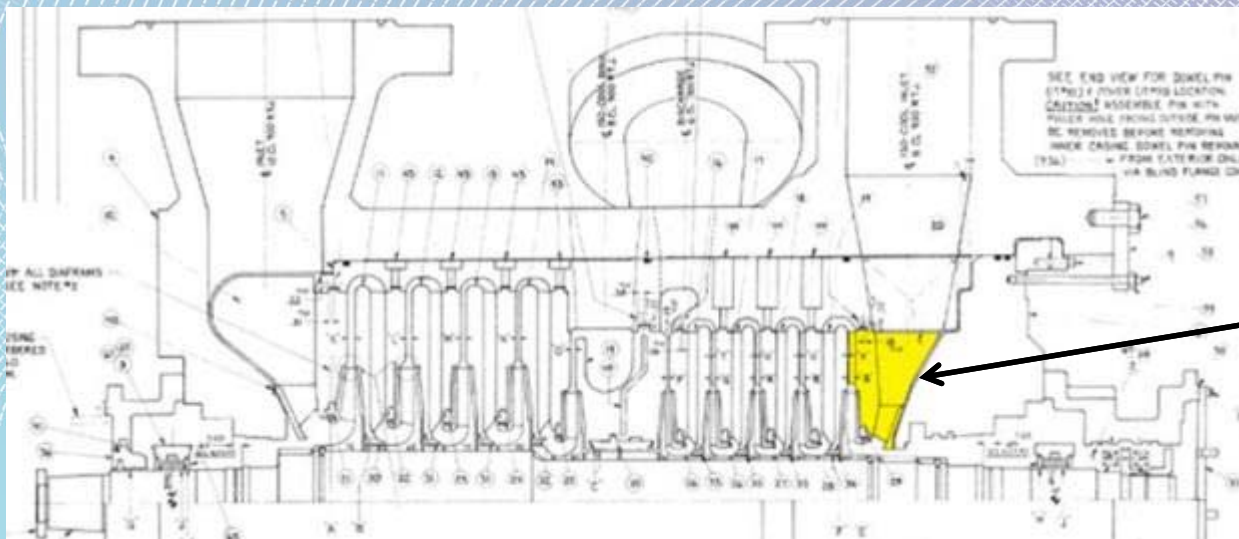
Compressor Assembly Cross Section

*Inlet Diaphragm
Highlighted in Yellow*

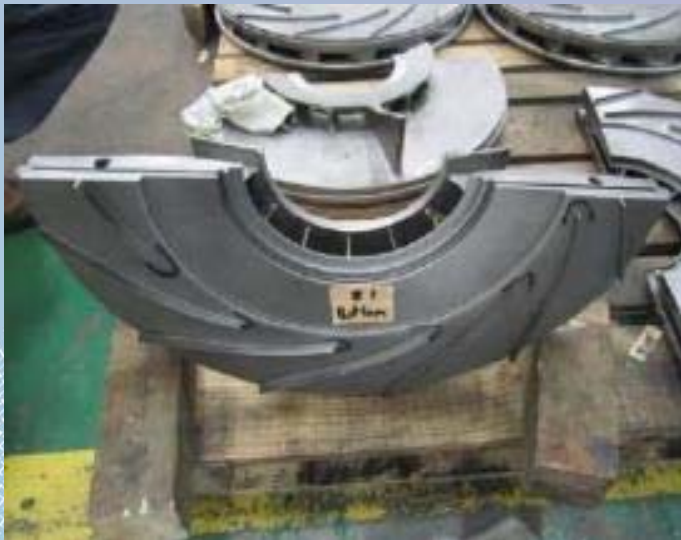
- A compressor train removed for overhaul in June 2011
- HP inlet diaphragm vanes found eroded (70% material loss)
- >6 months of lead delivery time for new diaphragm

HP inlet diaphragm (bottom)

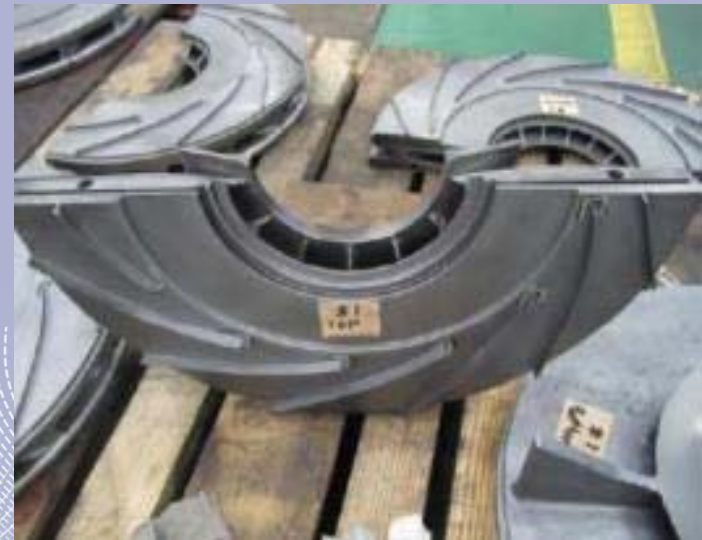
HP inlet diaphragm (top)

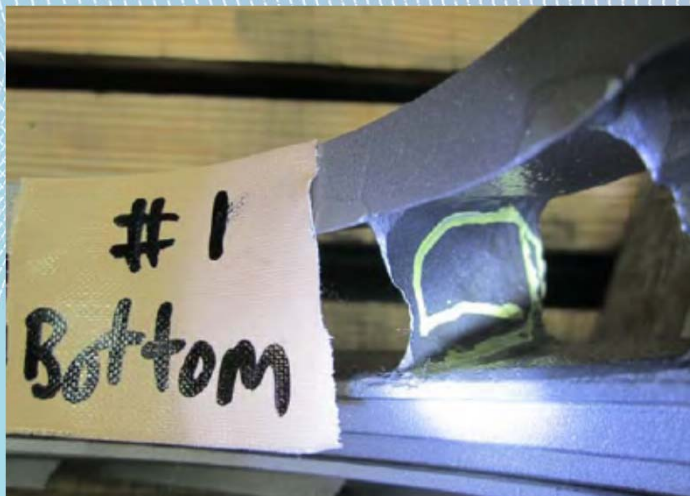
Eroded vanes(bottom half)

- 1 stop comprehensive engineering service provider
- Increase vane thickness (short term)
- Conduct trial run to ensure adhesion effectiveness
- Alloy deposition on vane
- Copper application – material buildup
- Nickel cap – bonding + hardness & erosion resistance

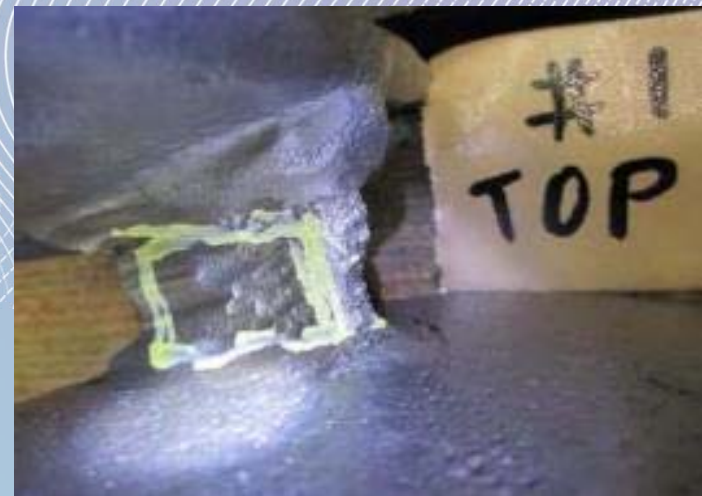
Eroded vanes(top half)

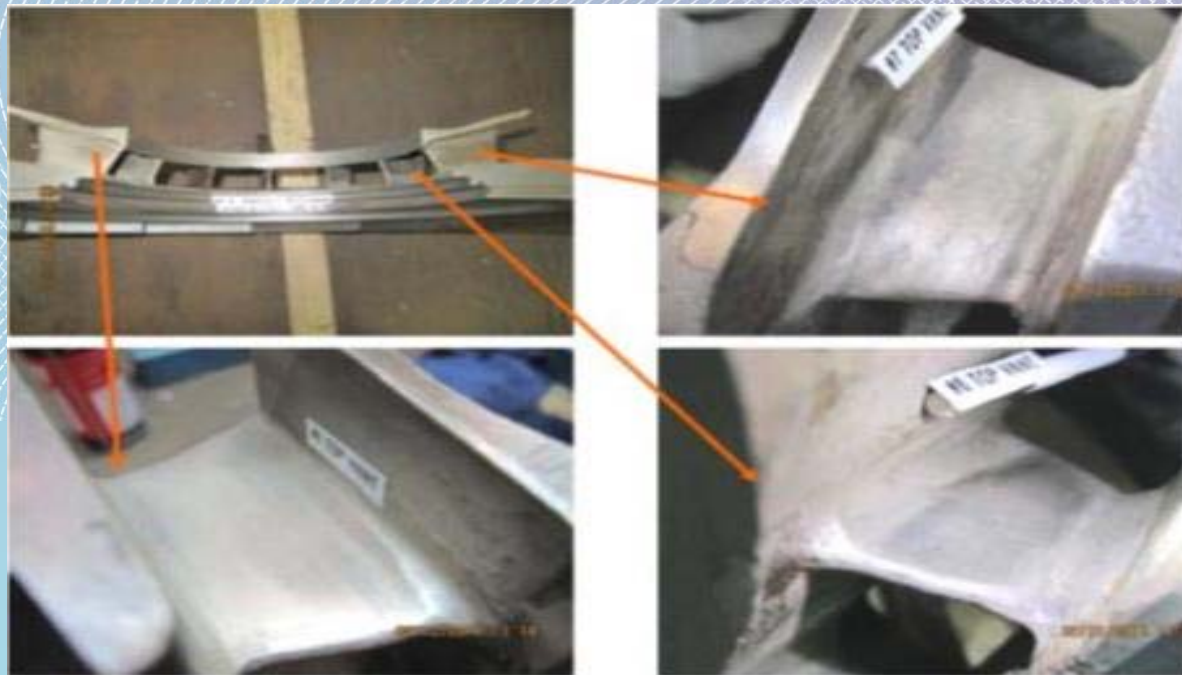
Repaired top half of diaphragm

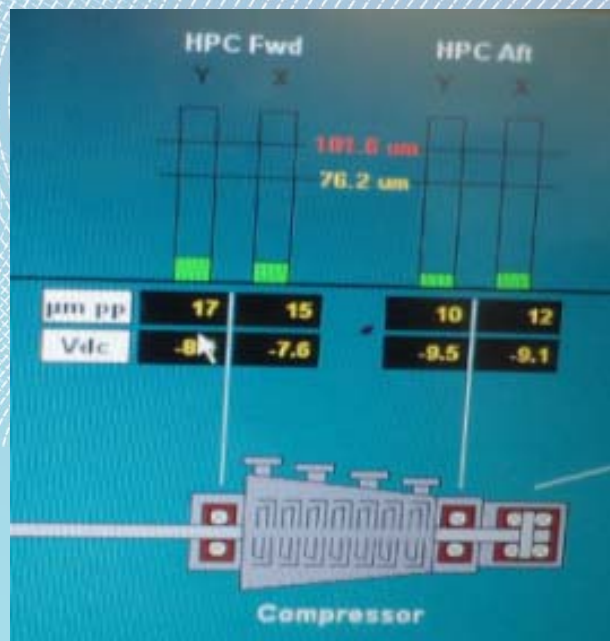
- Debonding was a possibility with flakes coming off
- Gas flow obstruction or worst case, compressor overhaul
- No similar past experience with this type of repair
- Developed sample bend test – adhesion verification
- Monitor compressor vibration channels as safeguard

**Compressor vibration
HMI screenshot**

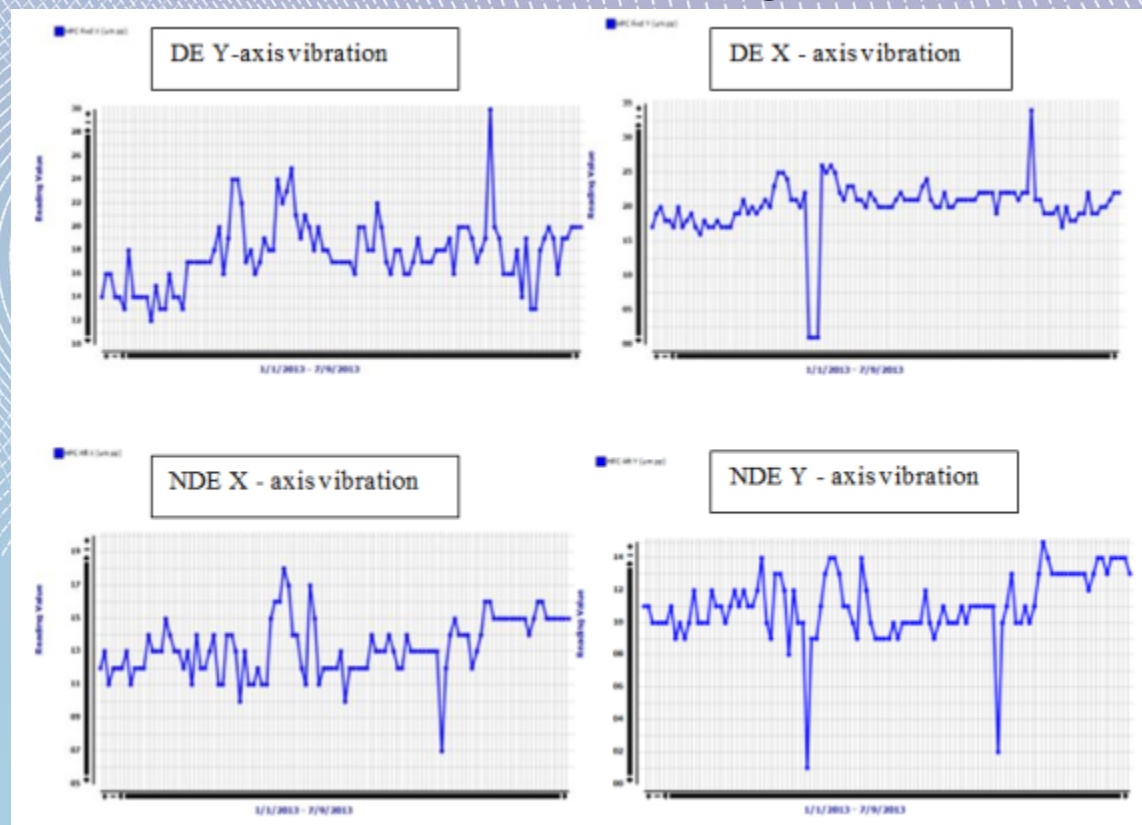
Vibration trend DE and NDE (Jan to Sep 2013)

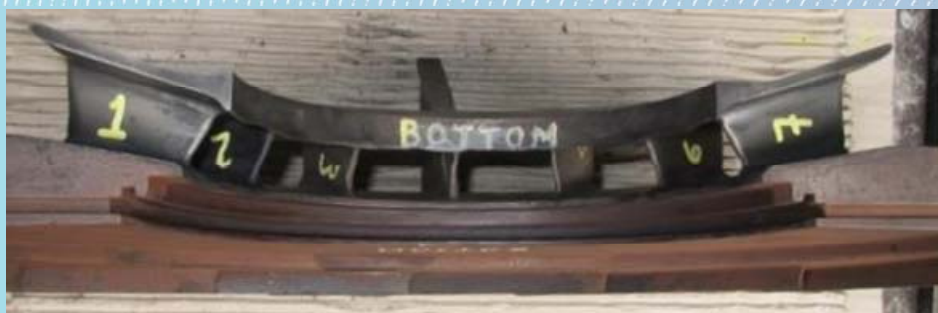
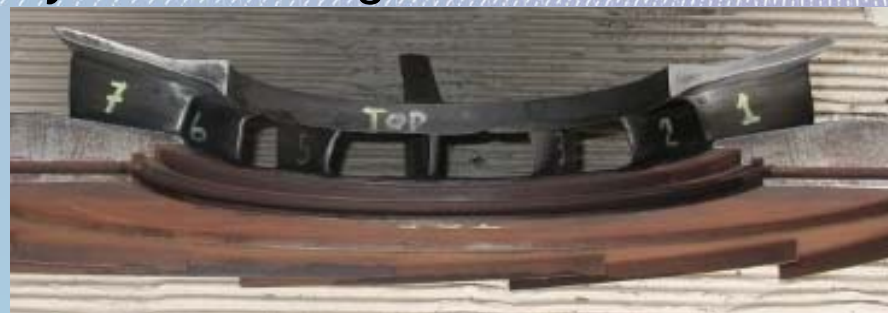
Diaphragm After Plating

- ^ blades selected for brush-plating due to severe erosion
- blade thickness is measured 2mm away from the edge

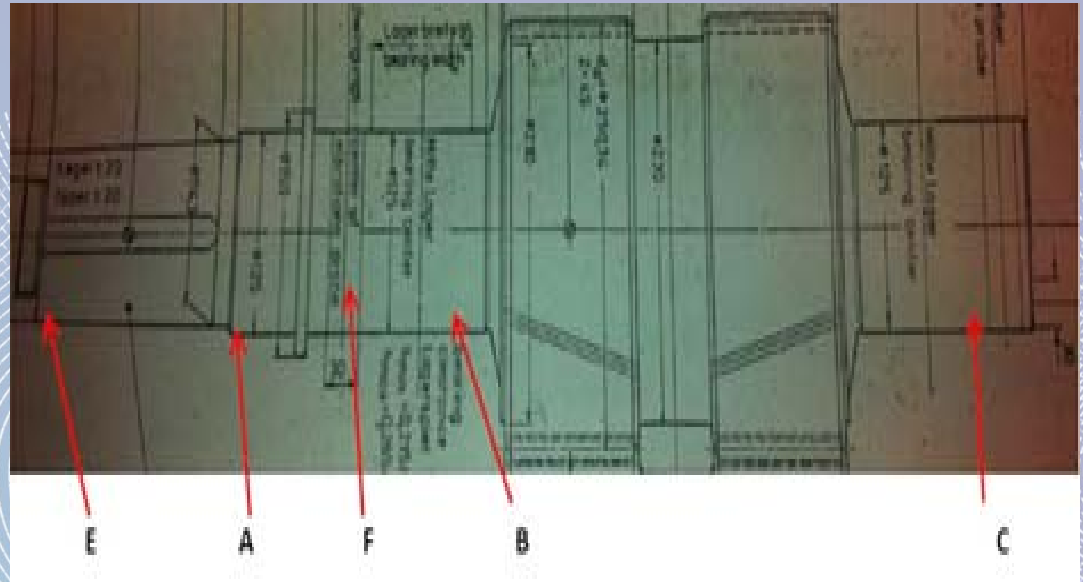
- First coupling failure (Train A) led to bent output shaft 1 driving Low Pressure Compressor Coupling
- Second coupling failure (Train B) led to bent output shaft 2 driving High Pressure Compressor Coupling

Dial Indicator Run-out Readings (units in mm)

C=NDE Journal	B=DE Journal	A=Shoulder at Taper	E=End of Taper
TDC	0.0	0.0	0.0	0.0
90°	+0.07	0.0	-0.01	+0.29
180°	-0.05	-0.03	-0.01	+0.10
270°	-0.13	-0.02	0.0	-0.23

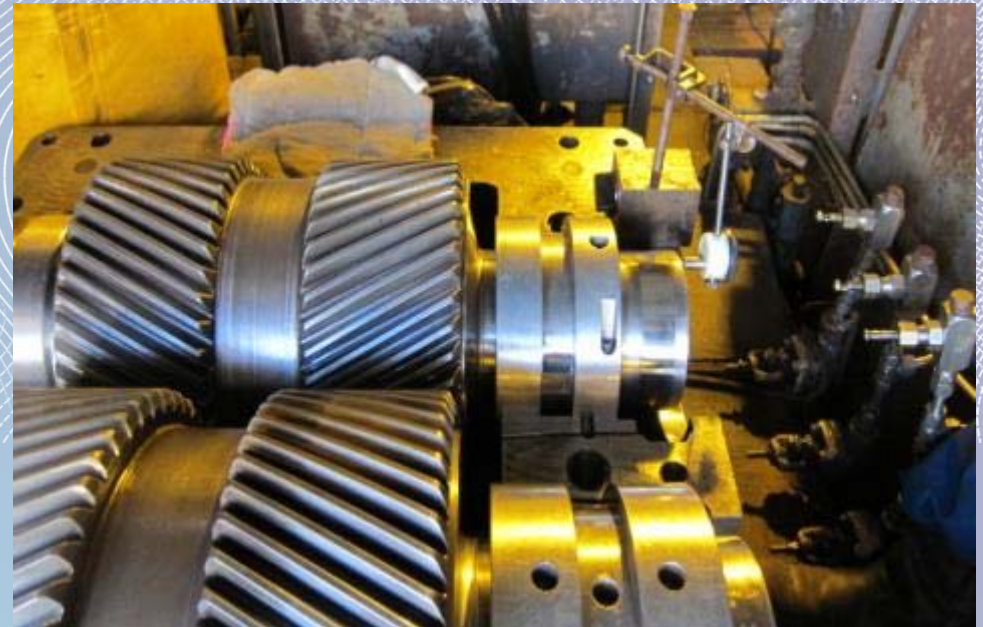
- Carried out tooth contact checks (verified 80% tooth contact area)
- Case-hardened gear tooth surfaces

Assembly and set up for on-site gear tooth contact verification

- Replaced damaged Output Shaft 1 from Train A with 'good' shaft from Train B

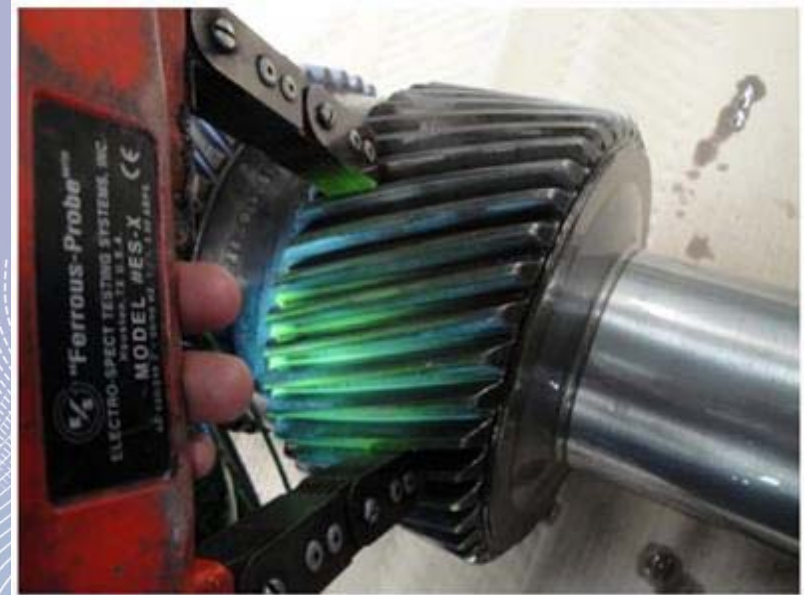
- Workshop run-out readings were almost identical to those at site (TIR approximately 0.2 mm)
- Balancing checks verified tapered shaft eccentricity
- Magnetic Particle Imaging (MPI) and Ultrasonic testing (UT) demonstrated no subsurface cracks or defects
- Rockwell Hardness to confirm material identity and yield stress
- **ASSESSMENT:** Rotor damage was confined to eccentricity thus repair options could be pursued

Above: MPI testing on gear teeth

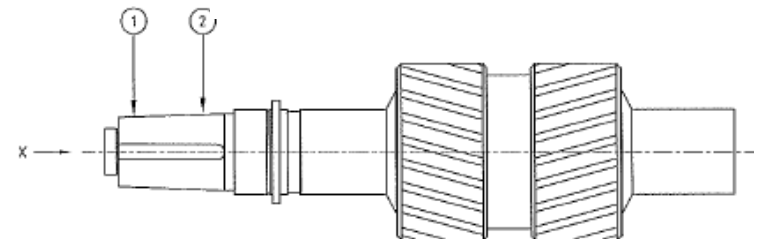
Below: Hardness test location and results

Incoming Hardness Test, unit: HRC

POSITION / NO.	1	2
A - D	22.5	20.6
C - B	20.1	22.2

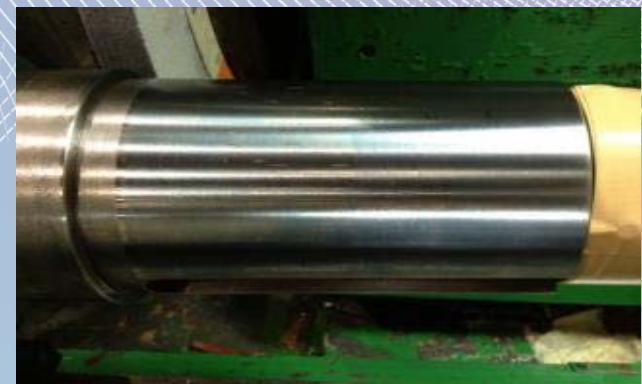
*Completed Surface Finish
(roughness 0.266 micron)*

- Hydraulic press reduced shaft TIR from 0.2 mm to 0.05 mm
- Surface grinding successfully restored TIR to within 0.01 mm (shortened shaft by 1 mm)
- **SAFETY!:** Rotor balancing, MPI, UT and Die-penetrant tests showed rotor to be acceptable
